# Correlating ERT with AEM in a rock slide mapping project, same shape but different quantities

Andi A Pfaffhuber<sup>1</sup>      Sara Bazin<sup>1</sup>      Matt J Lato<sup>1,2</sup>      Ulrik Domaas<sup>1</sup>

1) NGI  
 Sognsveien 72, 0855 Oslo, Norway  
 aap@ngi.no

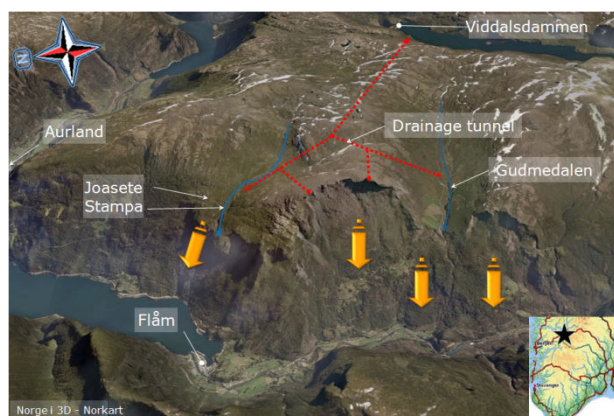
**Figure 1:** Study area (aerial photography draped over topographic model courtesy of [www.norgei3d.no](http://www.norgei3d.no)) indicating areas with known previous rockslides and creeping movements (orange arrows) of both massive rock (fjord) and loose debris (valley) partly driven by pore water delivered by the Stampa and Gudmedalen catchments. Red lines indicate the potential water drainage tunnel system.

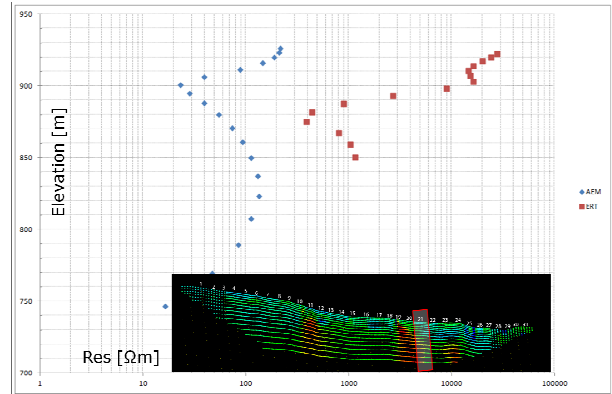
**Figure 5: Resistivity depth sounding extracted from ERT (red) and AEM (blue).**

Aim of the Airborne Electromagnetic (AEM) and ERT surveys was to find conductive clay within resistive phyllite. The concept of this geophysical / geohazards investigation is that on weakness zones phyllite tends to get crushed up and re-worked to its “parent”-mineral clay. Clay and shale have low resistivity overlapping in range with graphite. Unweathered igneous or metamorphic rocks, however, are characterised by very high resistivity of several thousand Ωm. ERT/AEM are consequently ideal tools to distinguish between soft, water saturated sediments and massive rock. Even though both methods identify the same conductive features in terms of location and geometry, there seems to be an offset in terms of the derived resistivity (Figure 5). It’s difficult to point out one isolated reason for this as several
